## THE prEN 17121: HISTORIC TIMBER STRUCTURES - GUIDELINES FOR THE ON-SITE ASSESSMENT OF LOAD-BEARING TIMBER STRUCTURES.

*The intention of this paper is to present the summary of the prEN 17121, a European standard proposal that will be published within 2019.*

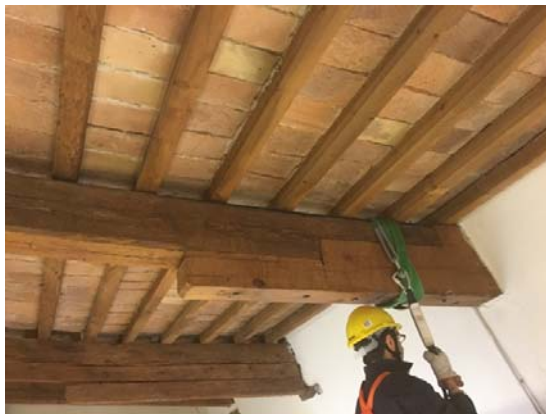
**Figure 1:** operators must have a safe access to the structures

Before analysing the operational parts of the document, it is worth underlining three main aspects strictly related to the survey methodology. First, any survey and diagnostic method used for the assessment of heritage structures shall be semi or non-destructive. Second, the assessment results pertain to the moment of the assessment, since degradation is a continuing process. Third, any survey must be carried out meeting the following conditions: structural safety, health safety, appropriate accessibility, accompanied by the right lighting and the cleanliness of the members to be examined (Figure 1).

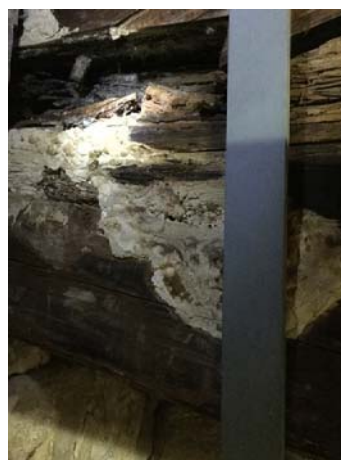
**Figure 2:** an important fungal rot at a tie-beam rafter joint. The external appearance does not allow to infer the real residual cross section.

For sections with a biological attack, or where insect attack is confined to a well-defined area of the cross section, the effective cross section shall be measured and used to calculate the strength (Figure 2). Non-destructive or low-destructive techniques may be used to help the estimation of the effective cross section; the method used shall be recorded, remembering that the strength of wood attacked by fungal rot is always equal to zero and that the insect attack on the surface of large cross-section members may be ignored.

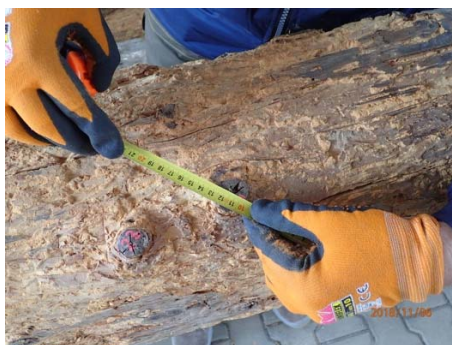
**Figure 3:** measurement of knot dimensions and position along the member

The European standard EN 14081-1:2016 [4] lists the strength reducing characteristics that must be used to visually strength grade the members, according to their dimensions and position. In detail the strength-reducing characteristics measurable in a non-destructive way during a detailed on-site survey are knots (Figure 3), grain deviation and shrinkage fissures, evaluated by an experienced specialist in wood and timber structures.
