## Seismic vulnerability of the Algarve coastal region

**ABSTRACT:** The Algarve is the national area, the most exposed to the action of the Bank of Gorringe, place to which are allotted the epicentres of higher magnitude earthquakes that ravaged Portugal in particular 60-63b.f., 1033, 1356 and 1755. However, despite being characterised by a reasonable geographical uniformity, the territory of the Algarve presents considerable variation at the level of impact occurred, both of a general historical analysis, and with respect to specific occurrences. The case studies chosen, regardless of the geological similarity, territorial proximity, and the high degree of devastation that they underwent, are primarily characterised by the divergence of the answers operated in the post-disaster context. From the complete abandonment of the settlements to the immediate reconstruction, the use of pre-existence to the full redefinition of the clusters structure, the Algarve offers a wide variety of approaches when considering how this region adapted to the seismic phenomenon.

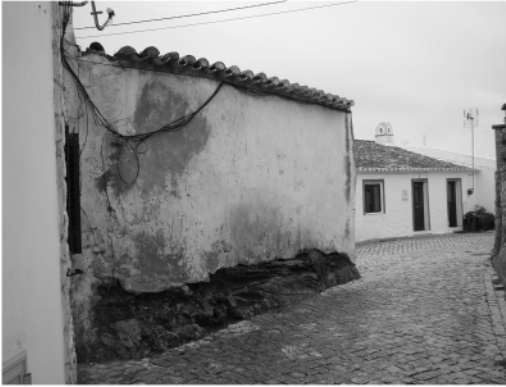
Figure 1. Rocky integration as structural *soco*, Vila do Bispo (credits: CI-ESG, 2013).

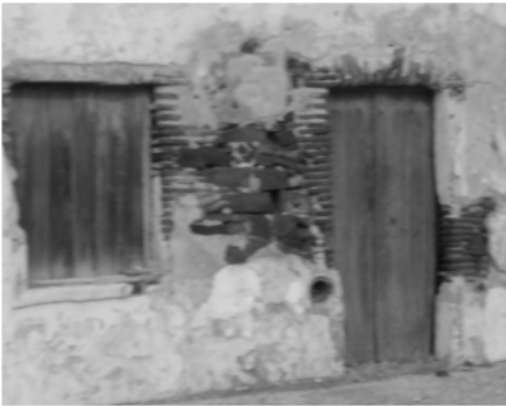
Figure 2. Trim reinforcement with *lambaz* brick (Credits: CI-ESG, 2013).

components in *lambaz* (solid) brick for use in openings reinforcement or discharging arches.

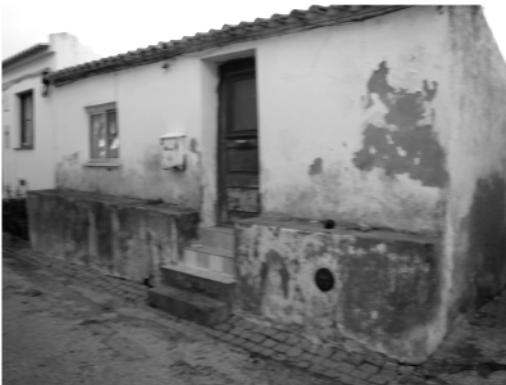
Figure 3. Rammed-earth building with reinforced plinth course, Bensafirim (Credits: CI-ESG, 2013).

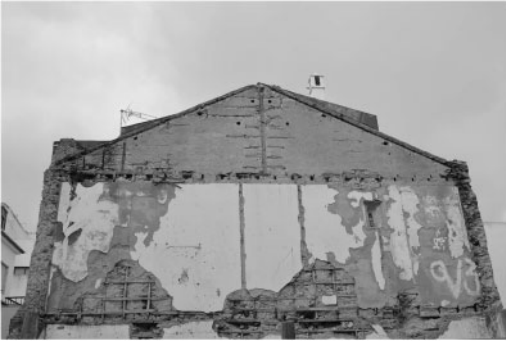
Figure 4. “Gaioleiro” system in Lagos (credits: Laura Felix, 2015).

As for the buildings constructed post-earthquake, reinforced plinth course, buttresses, bearing arches and 'gaioleira' (Fig. 4) walls were identified. However, despite its high number identified, the location of these elements is scattered and punctual, revealing no direct linkage with any constructive technique or architectural typology.

The analysis to some ruins also enabled the testing of a correlation between the construction method and its time of construction, allowing a better identification and understanding of the buildings of the same era. Some ruins presented the use of 'gaiola' systems on the walls of moiety. These systems were extremely simplified, generally without the presence of diagonal elements, and composed only by the vertical wooden elements (plumbs) and the horizontal elements (wind-sill), sometimes reinforced with the inclusion of some metal elements.

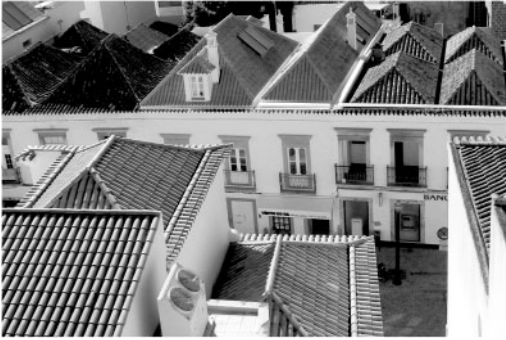
Figure 5. 'Telhado de Tesouro' in Tavira (credits: CI-ESG, 2015).

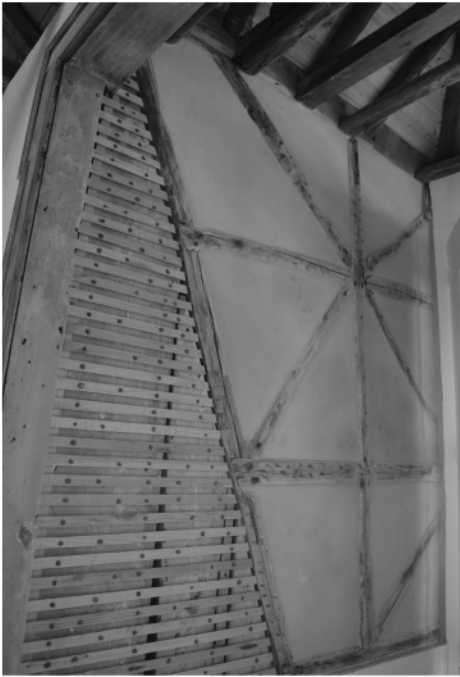
Figure 6. “Gaioleiro” system in Vila Real de Santo Antonio (credits: CI-ESG, 2015).

The buildings, built according to the 'Pombalino' model, turn naturally to the cage system, with a significant reduction of the wooden skeletons sections and the corresponding stone masonry. The wedges and the spans are fully implemented with limestone fittings. The ground floor, only built in stone masonry, takes back the structural *soco*, using a covering system sustained by arches. The upper floor refers to the combined 'Pombalino' system (with the caveats already mentioned), integrating in several cases, the systematic application of metal tethers on the facade, especially in the anchorage of the upper floors pavements. The remaining buildings or their wall-backing supplements are of great constructive simplicity. These resort to ordinary masonry stone or brick systems. In these buildings, the application tethers across the main facade, is still often, though not carried out systematically.

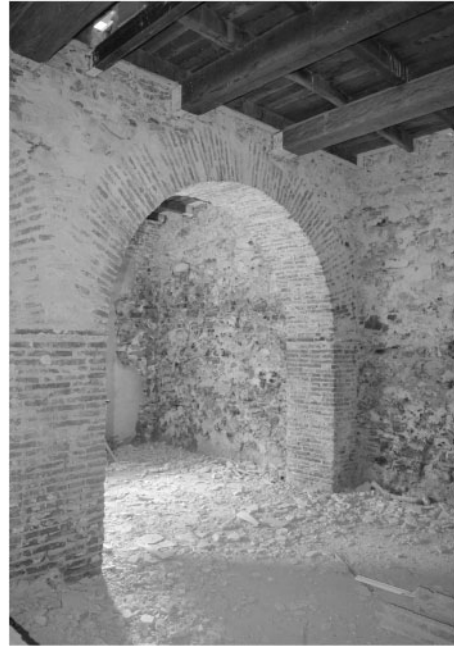
Figure 7. Covering system sustained by arches in Vila Real de Santo António (credits: CI-ESG, 2015).
